CONTRACT FOR ENGINEERING SERVICES
Dunham Engineering, INC.

REPORT OF INSPECTION

CITY OF BRYAN

Enclosed please find the reports for the City's steel water tanks. The reports were prepared in accordance with AWWA D101 – Inspection and Repair of Steel Water Tanks. A summary of the results follows:

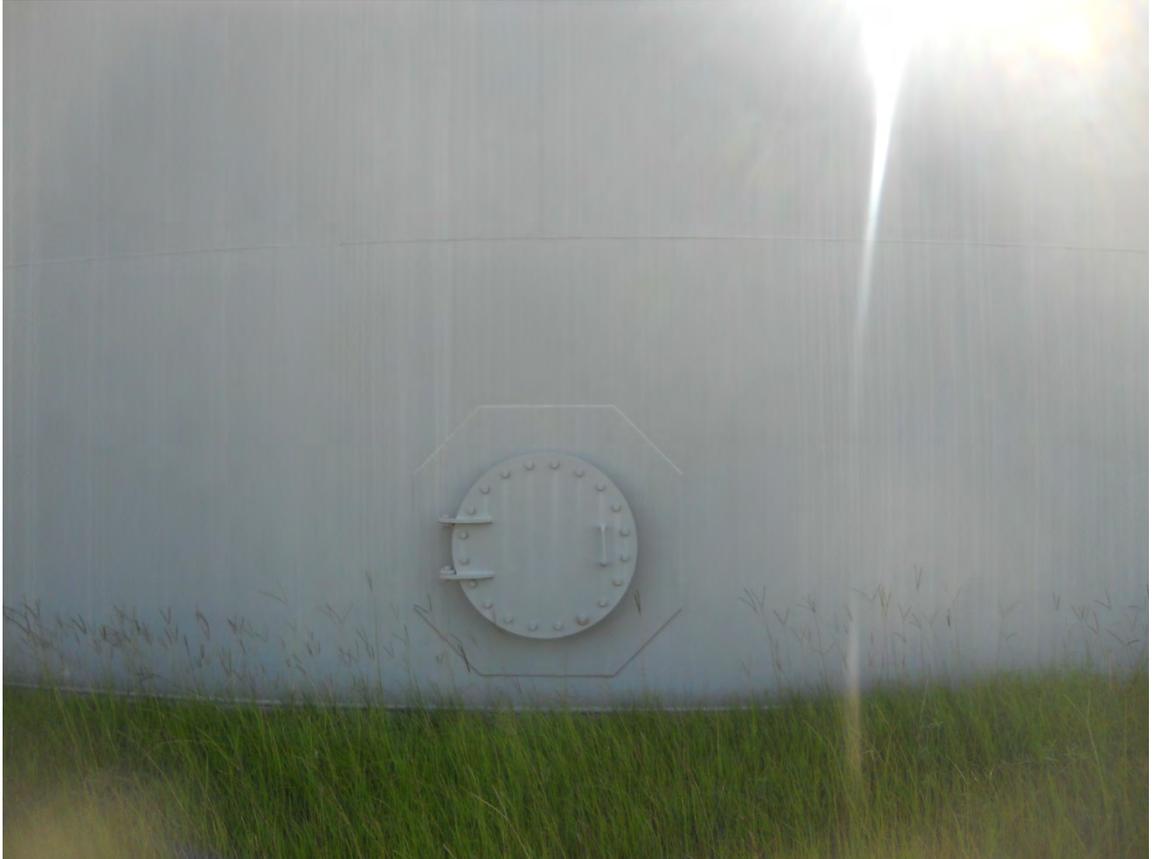
The 24" diameter manway is in good condition with no leaks or cracks noted. The manway cover was not opened and no leaks were noted. The weld seam on the neck is in good condition with no cracks noted.

Manway - undersized

- a. Replace the interior coating system now to prevent further corrosion damage to the interior steel.
- b. The top hatch and manway should be increased in size to meet current TCEQ standards when the coatings are replaced.
- c. The overflow pipe should be moved to the exterior to prevent a potential leak in the pipe from draining the tank.
- d. Budget \$325,000 including engineering fees to rehabilitate tank within 12 months. Delaying the replacement of the interior coating system could require replacement of interior rafters which could increase the cost of the project to \$450,000.

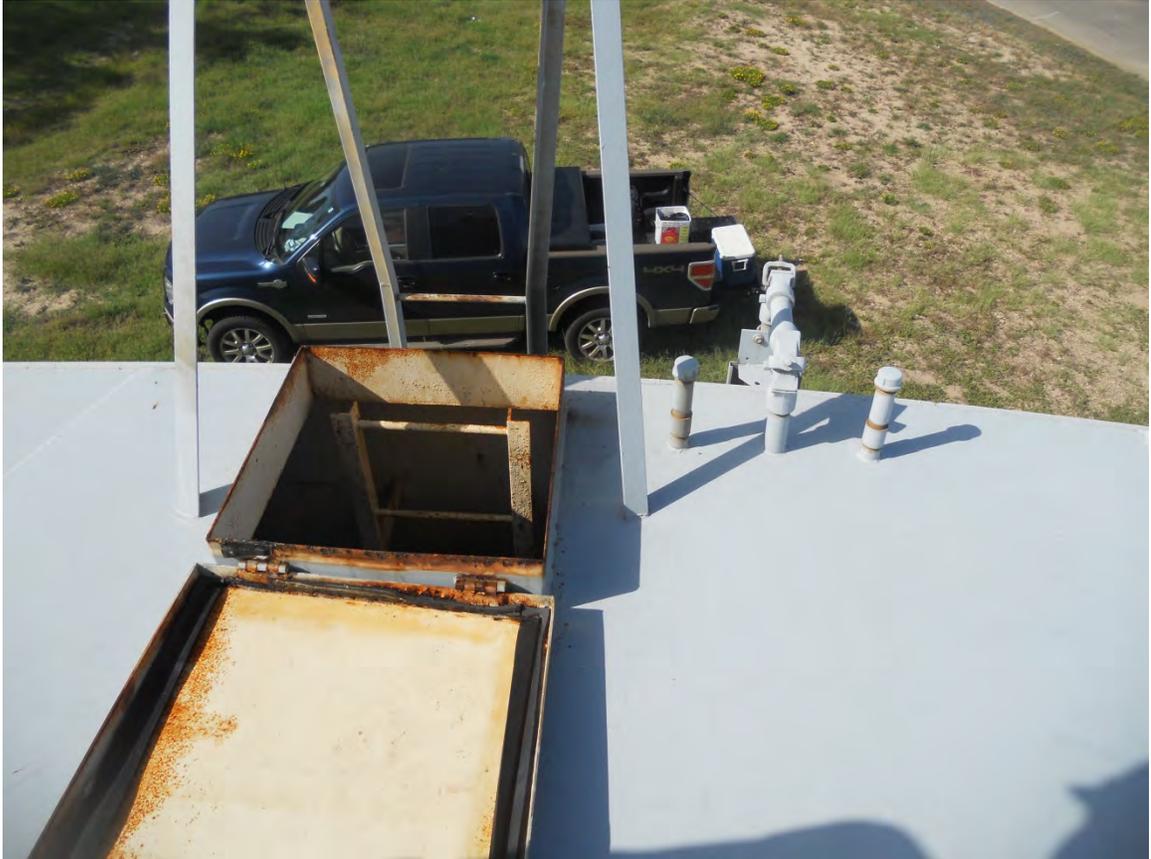
The 24" square hatch has a cracked hinge but locks properly.

Top hatch - undersized and broken hinge

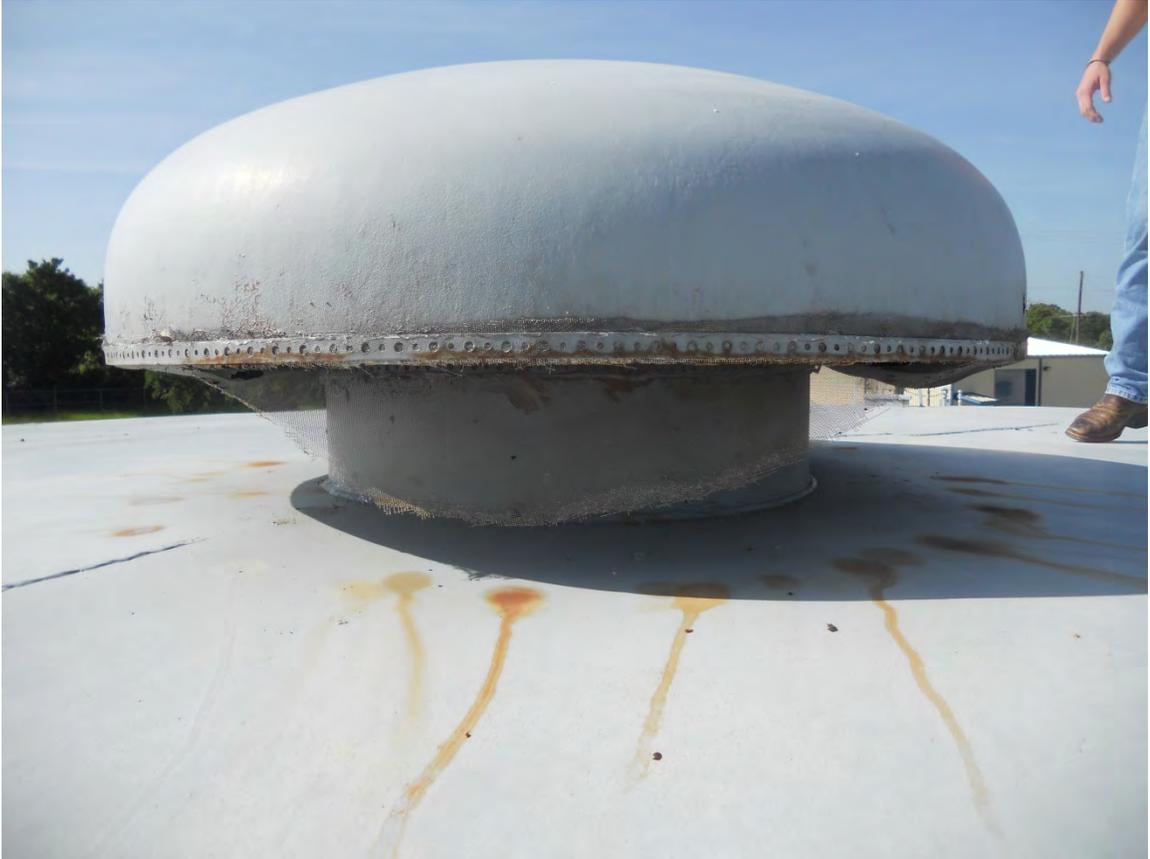
The 24" diameter top vent is not properly screened but is in good condition. The screen wire is torn in several locations.

Screen wire torn in several locations

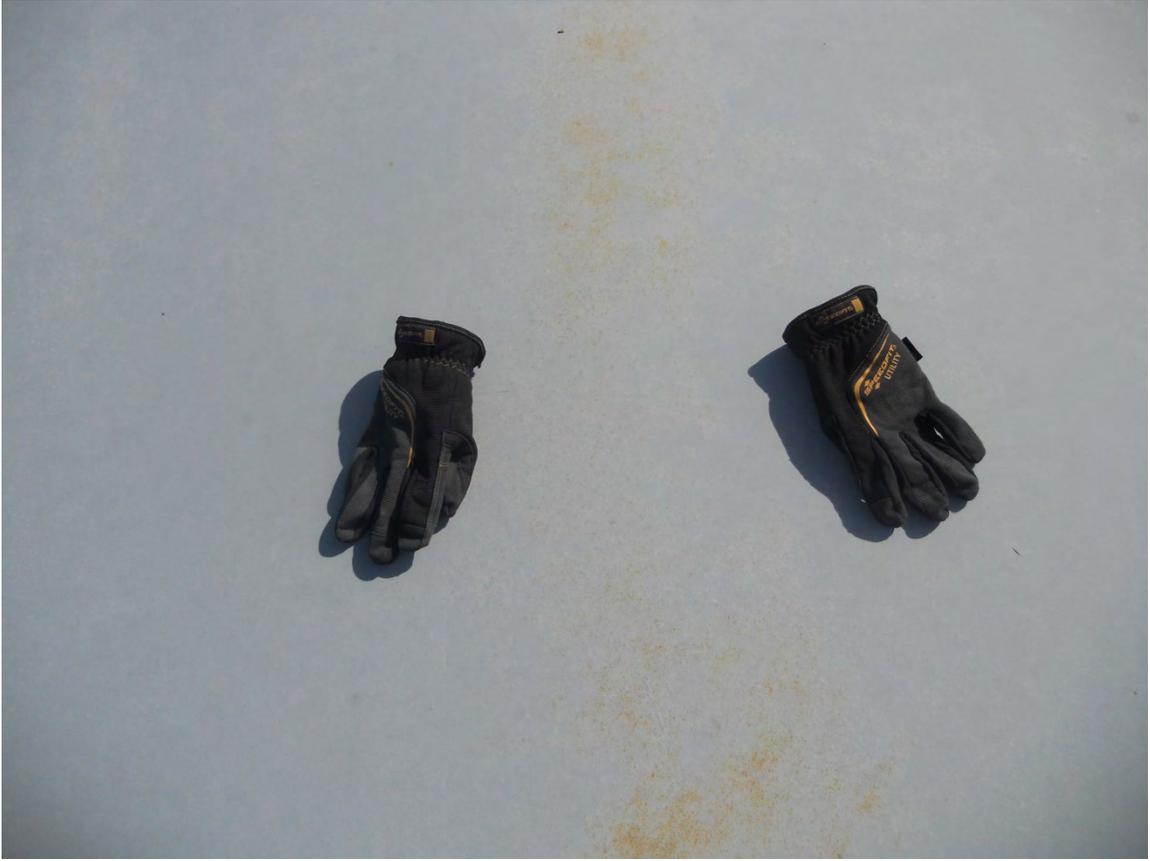
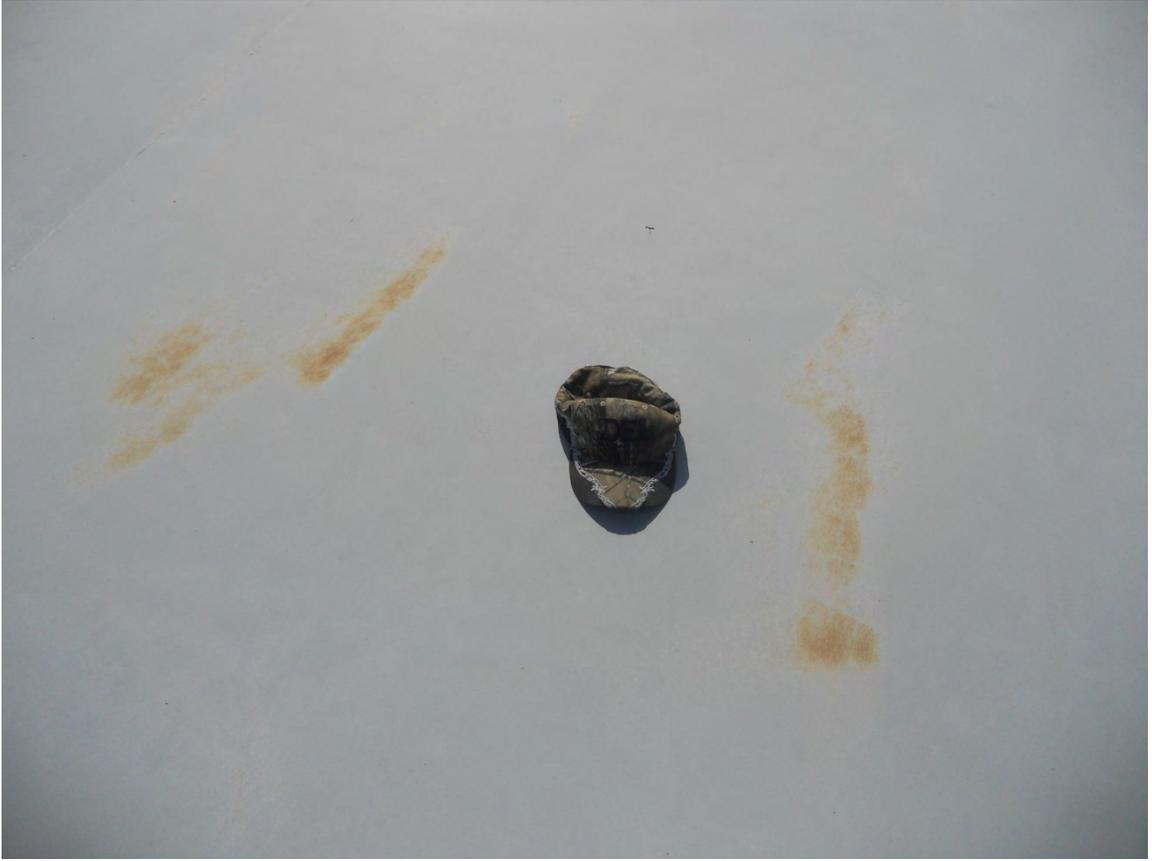
The roof is properly sloped and in good condition. Approx. 10% of the roof surface area is rusting. The interior plate is not welded or caulked at the seams. Several of the interior plate seams are corroded.

The exterior coating is in good condition with the exception of the roof coating. Approx. 10% of the roof exterior surface area is rusting.

Rust on roof

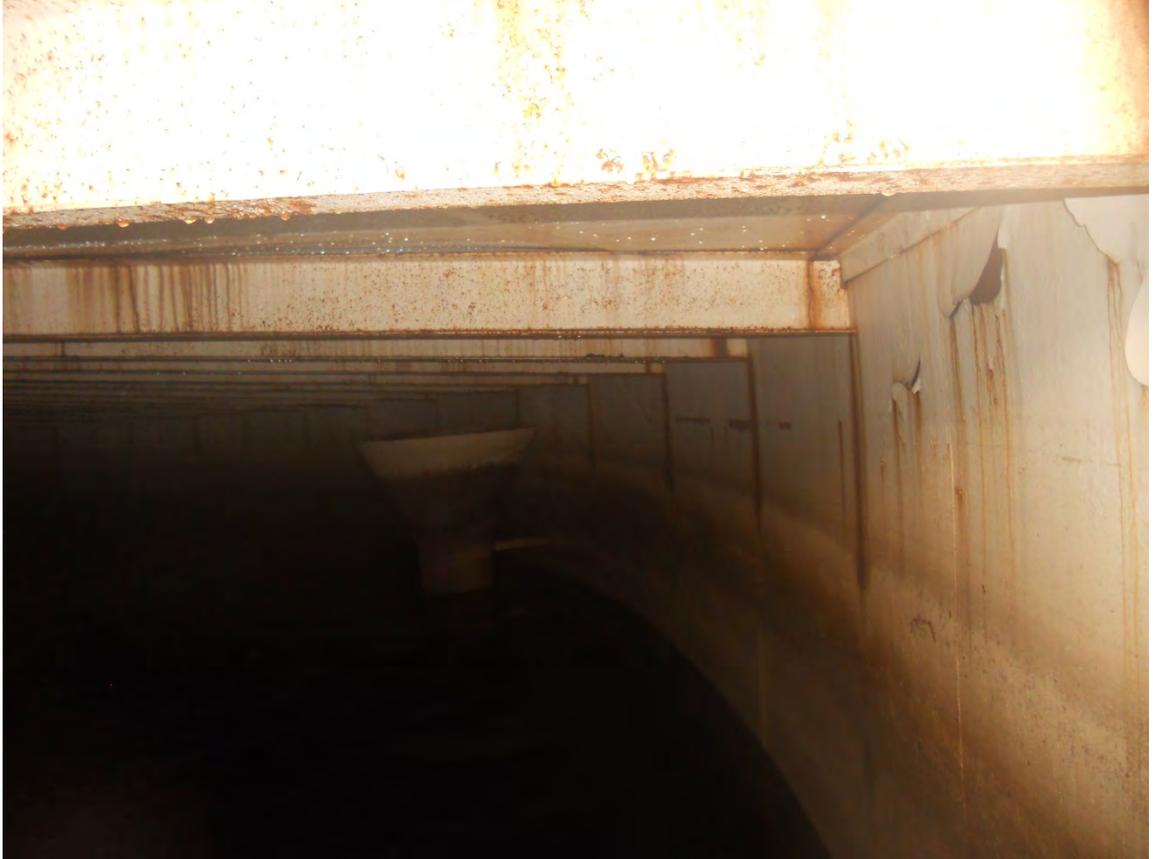
The interior coating is in poor condition with more than 15% of the total interior surface area rusting. The area above the high water line is cracked and peeling in several locations.

Cracked and peeling coating on wall - overflow inlet

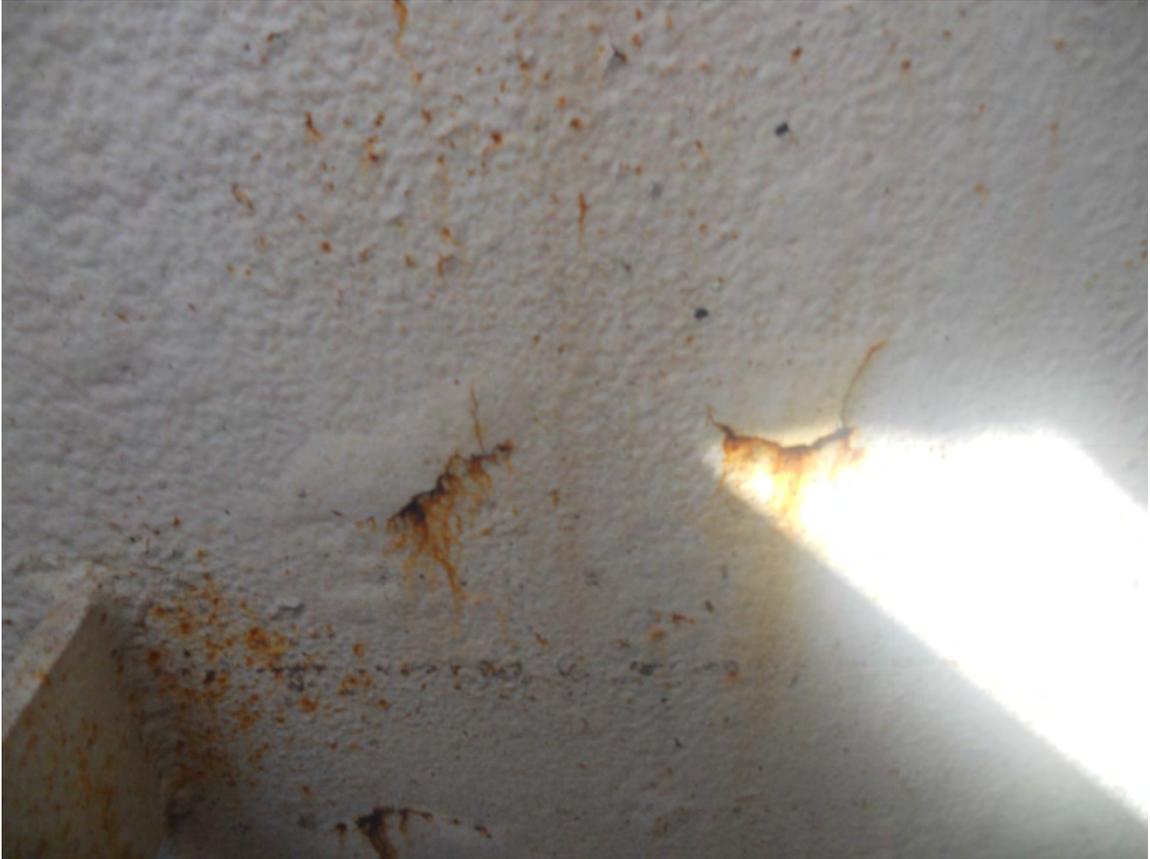
a. The tank is in good condition with the exception of the interior protective coating system. The interior coating system is more than 20 years old and no longer providing adequate corrosion protection to the steel.

Cracked and peeling interior coating

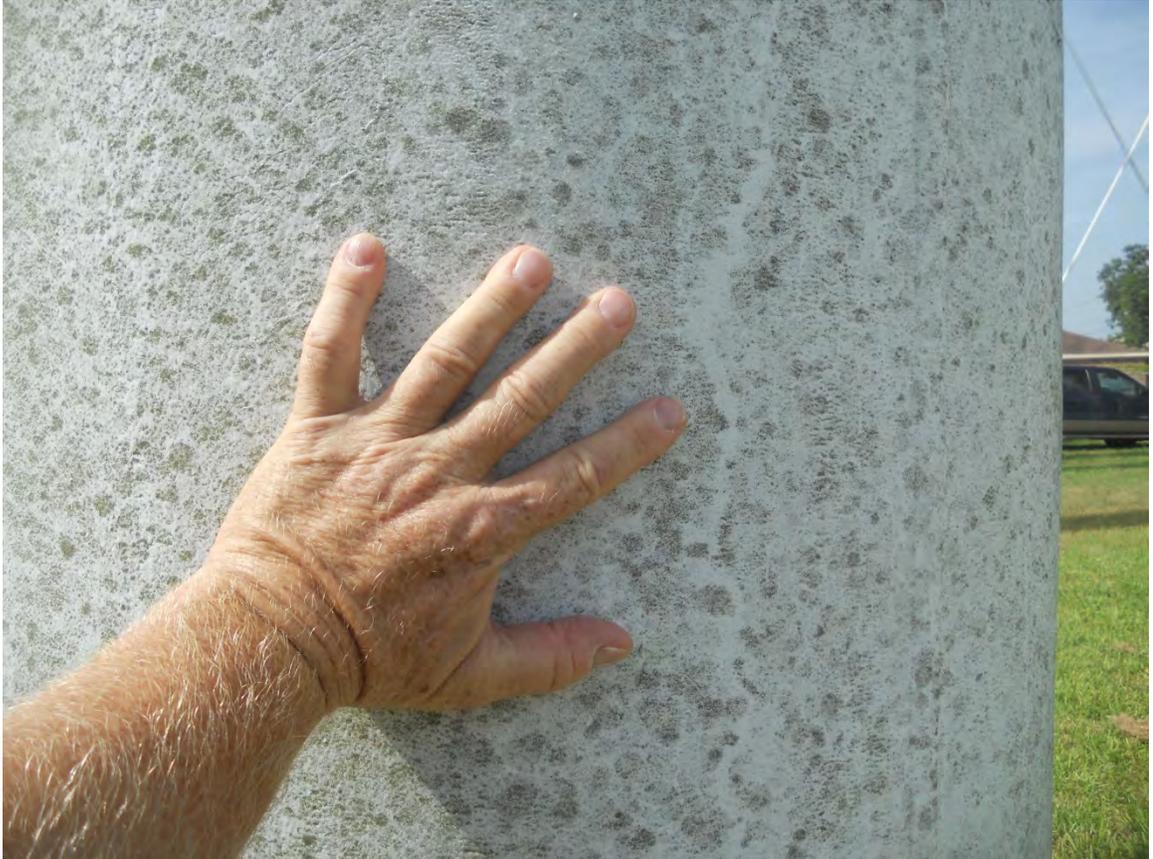
Exterior coating is dirty

- a. Over-coat the exterior system within two years (no later than 2016) to extend the life of the coating system. Budget \$250,000 to over-coat before 2016 or \$450,000 to replace coating system after 2016. Replacing coating requires complete shroud to sandblast entire structure to protect environment from nuisance blast.

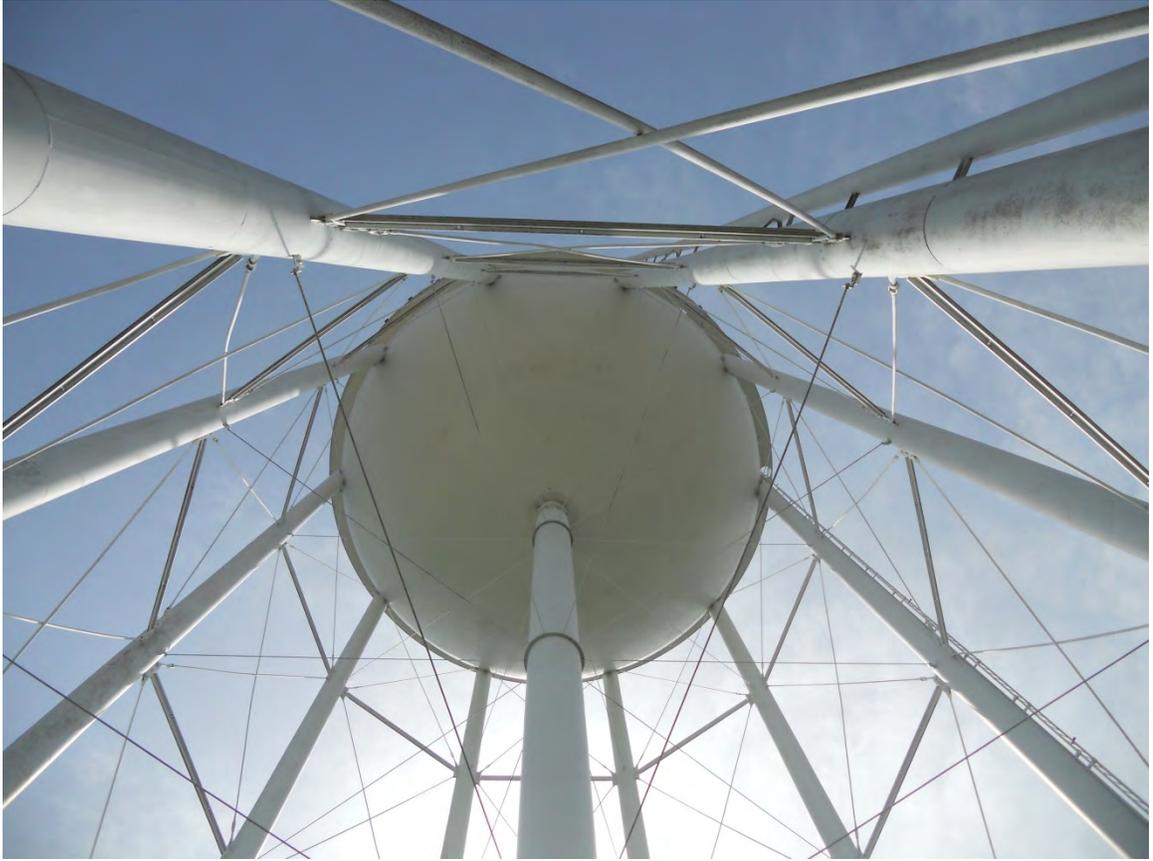
The wet riser pipe is plumb and shows no sign of leaks. The manway was not opened and is in good condition with no evidence of leaks. There is evidence of a minor pinhole leak at the weld seam on the junction of the pipe to the bowl.

- a. The structure is approx. 58 years old and in good condition.
- b. No water quality or TCEQ deficiencies were noted.
- c. There is a pinhole leak in the weld seam at the top of the riser pipe.

View of support structure and leak at top of riser pipe

- b. The leak on the riser pipe @ junction to bowl should be repaired at the same time as over-coating. Perform touch-up on the interior coating when welding repairs are completed. Budget \$50,000 for welding repairs and touch-up to interior coating while over-coating is being performed.
- c. Recommended budget figure to over-coat exterior and repair weld seam at riser and touch-up interior coating prior to 2016 including engineering fees is \$350,000.
- d. Delaying past 2016 will require removal of the coating systems and significantly increase the project cost to \$700,000.

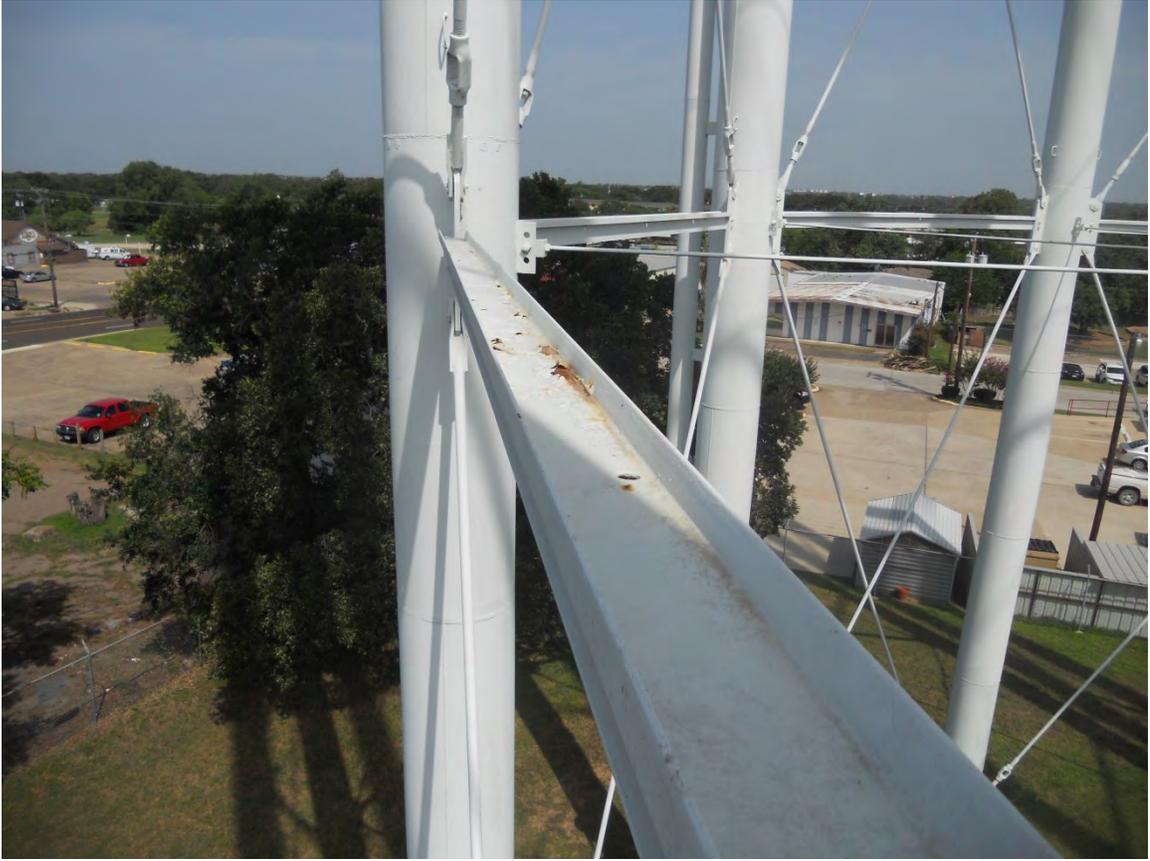
Rust on interior of strut

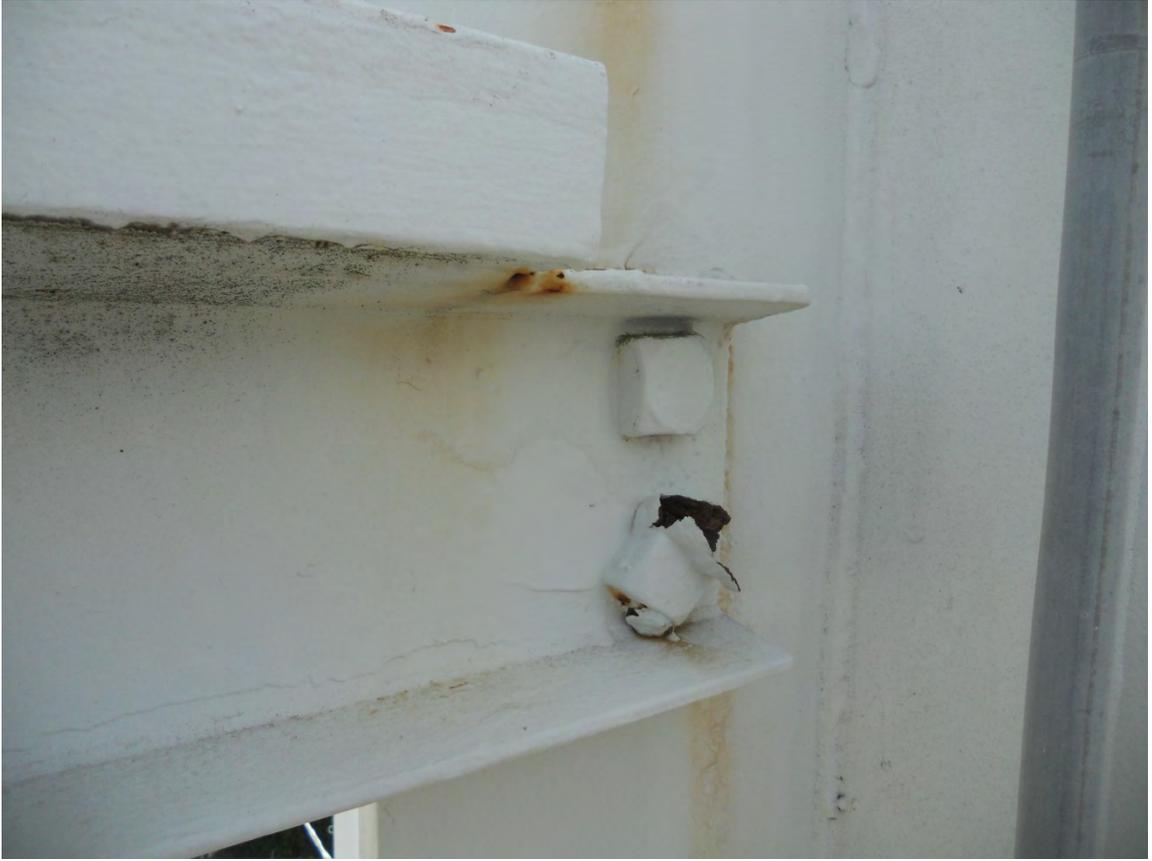
The wind rods and riser rods are straight with no excessive bending noted. The struts are level and in good condition. No problems were noted with their connections other than minor corrosion. The lower level of wind rods have been damaged by equipment (mowers) hitting the rods and scraping the paint.

Rust on strut connection

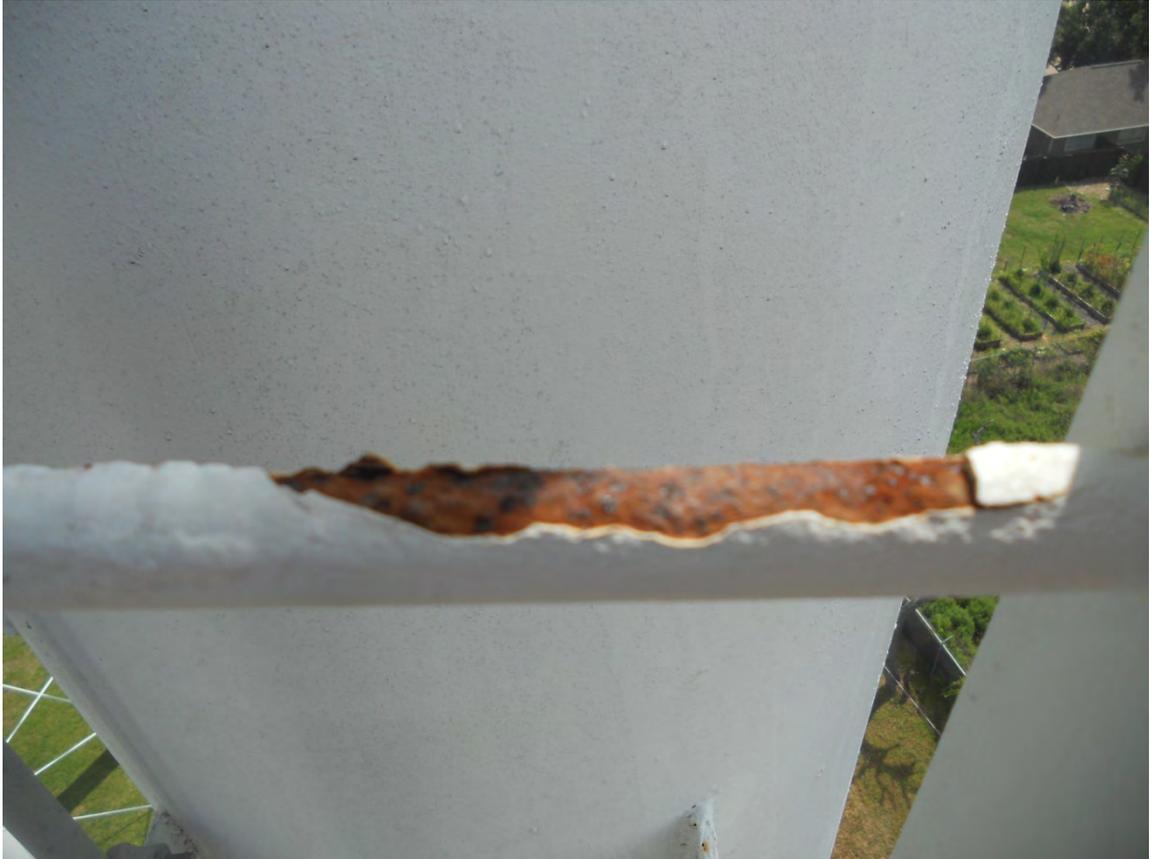
Damaged coating on ladder rung

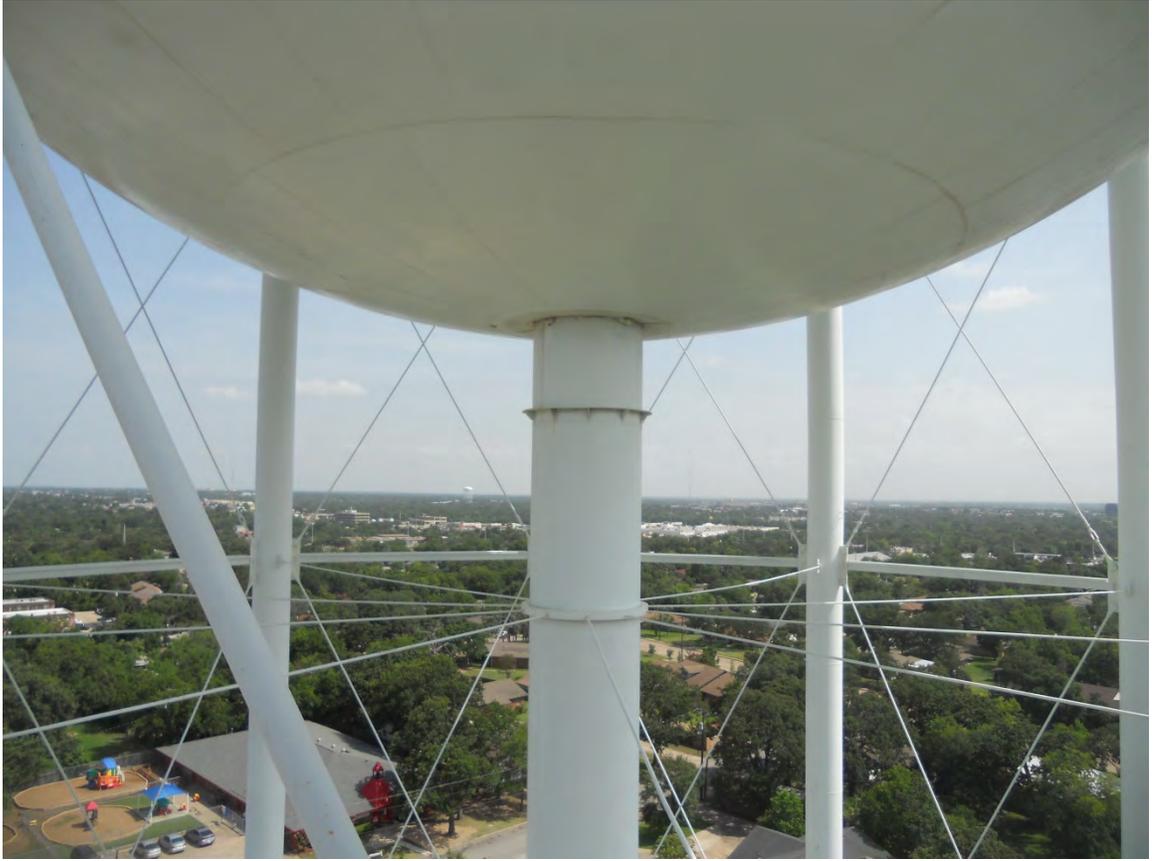
Riser-bowl junction

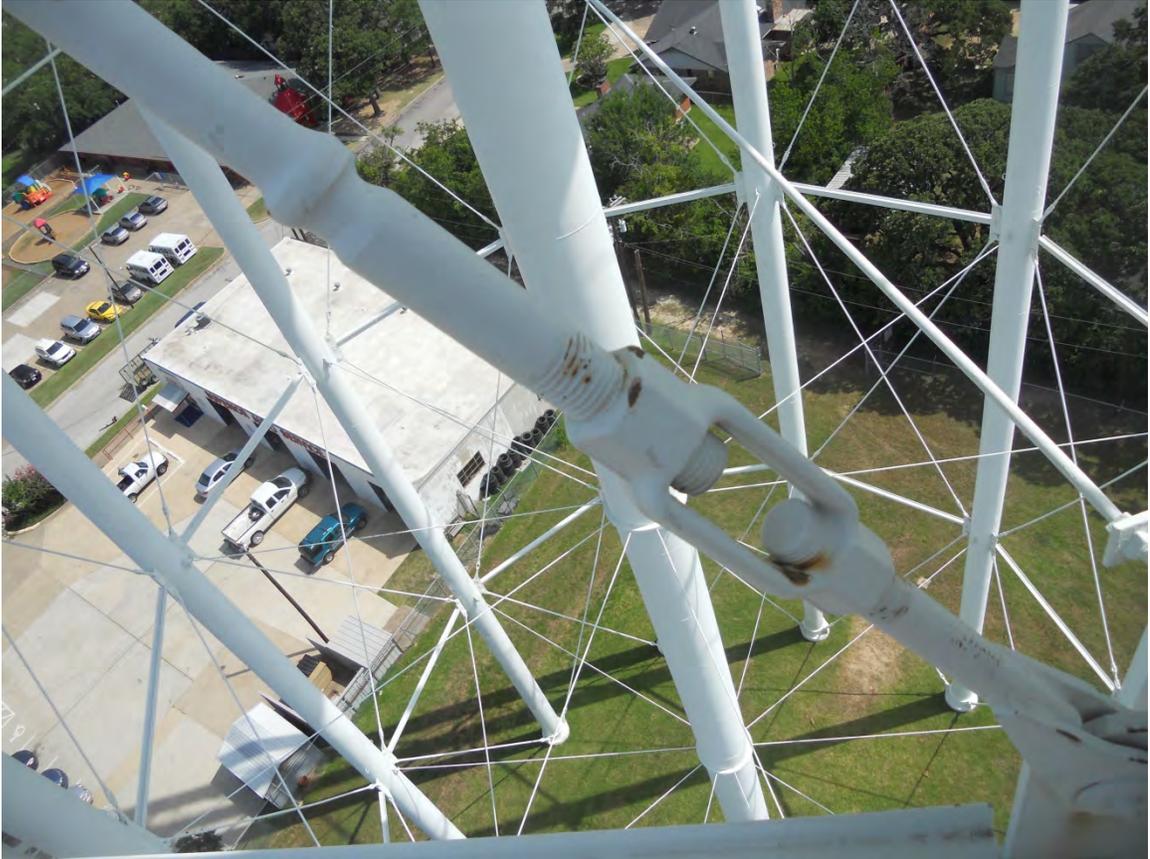
Rust on wind rod turnbuckle

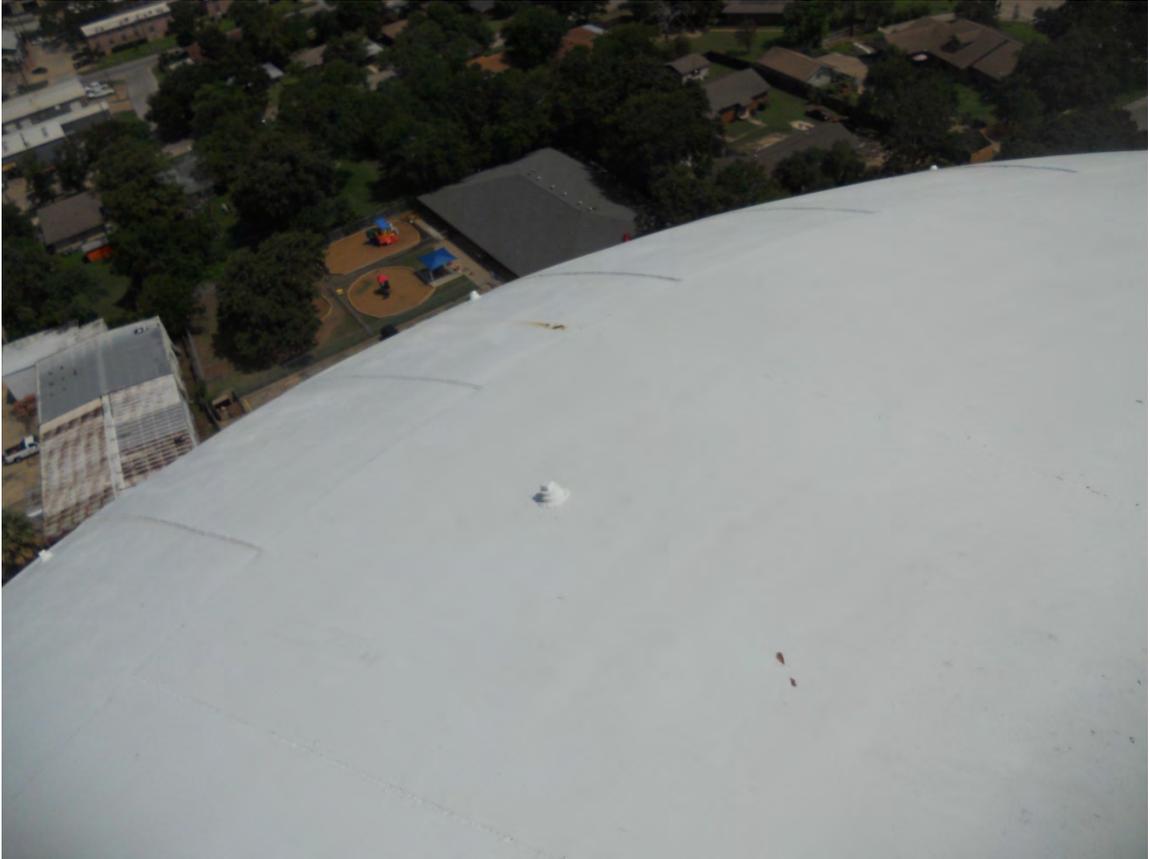
Coating cracked on roof and rigging nipples

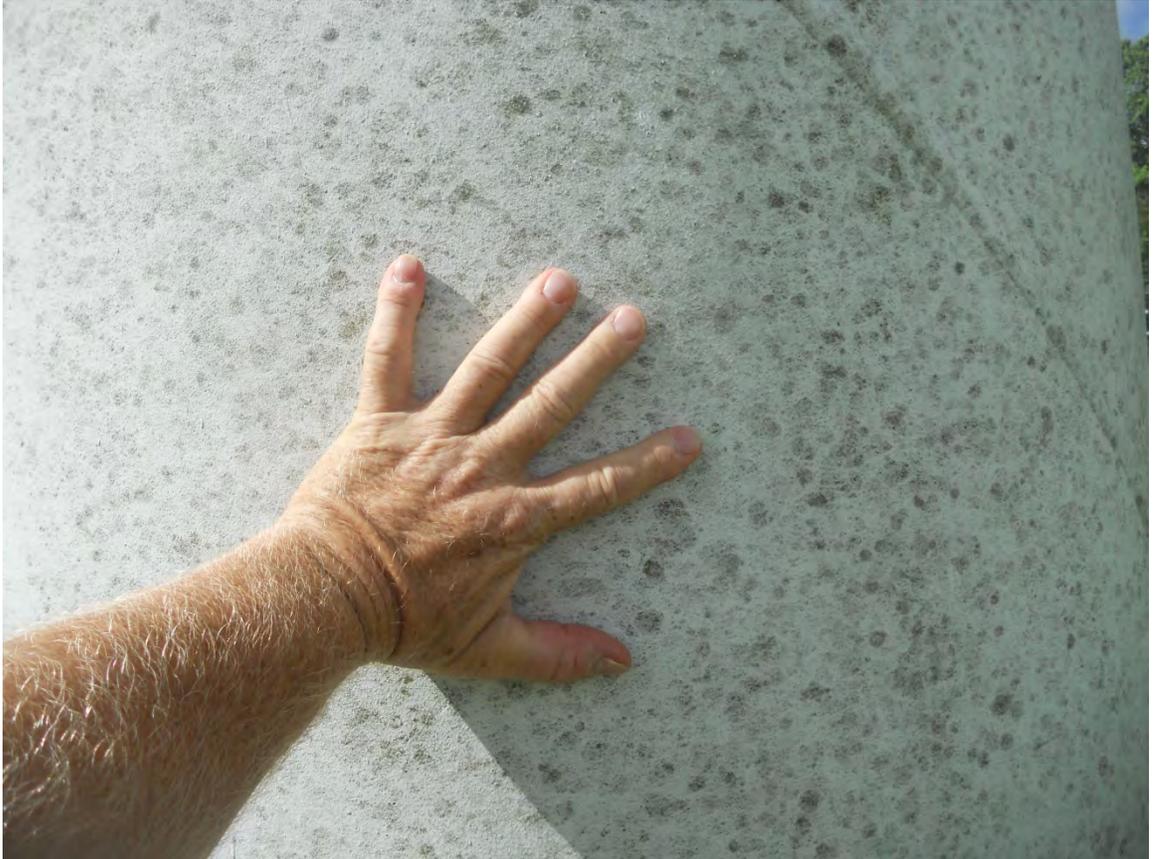
Exterior coating with dirt and debris

- a. Over-coat the exterior system within four years (no later than 2018) to extend the life of the coating system. Budget \$400,000 to over-coat before 2018 or \$915,000 to replace coating system after 2018. Replacing coating requires complete shroud to sandblast entire structure to protect environment from nuisance blast.

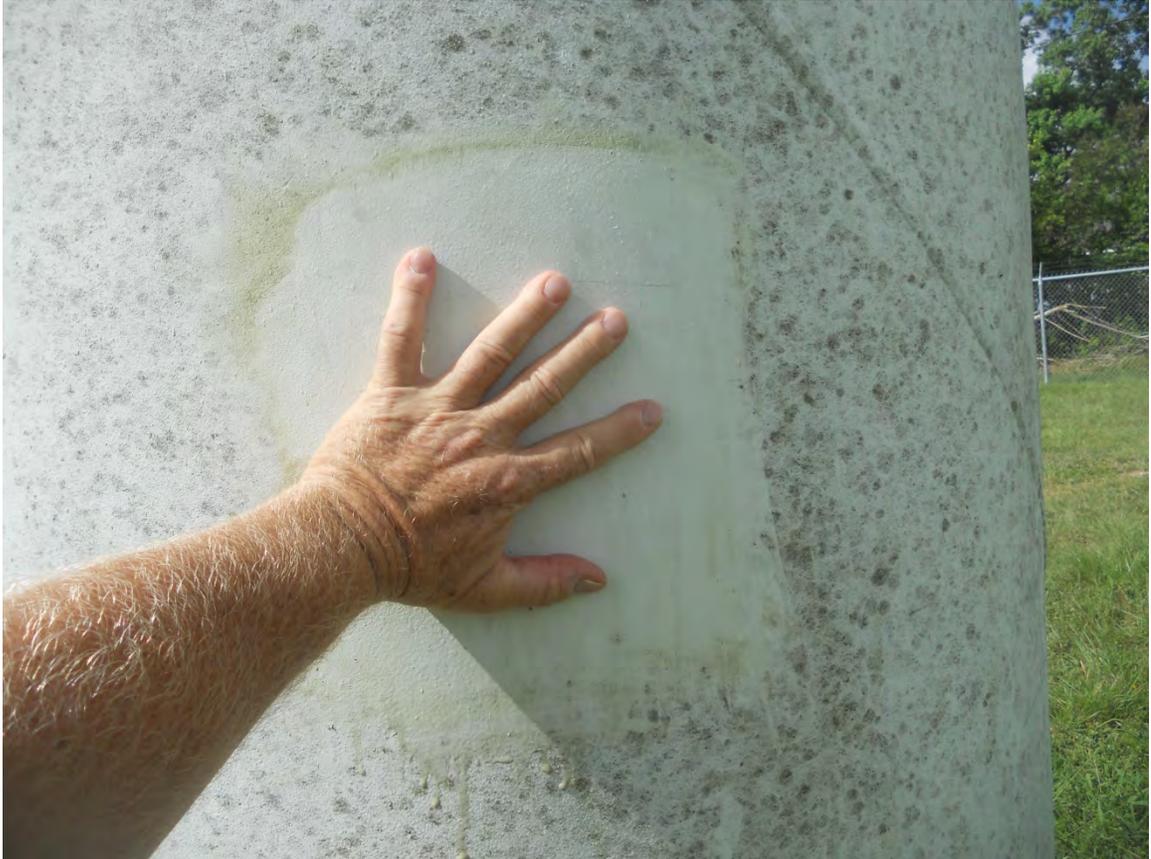
The exterior coating system of acrylic is in good condition and tightly adhered to the steel. A square foot section of steel was cleaned with water to reveal coating in good condition.

Same area cleaned with water and rag

Note: The exterior coating system is a dry-fall acrylic and was selected by City 15 years ago for the additional purpose of being able to over-coat as opposed to complete removal. The City can take advantage of the cost savings if over-coating is done while coating is still tightly adhered.

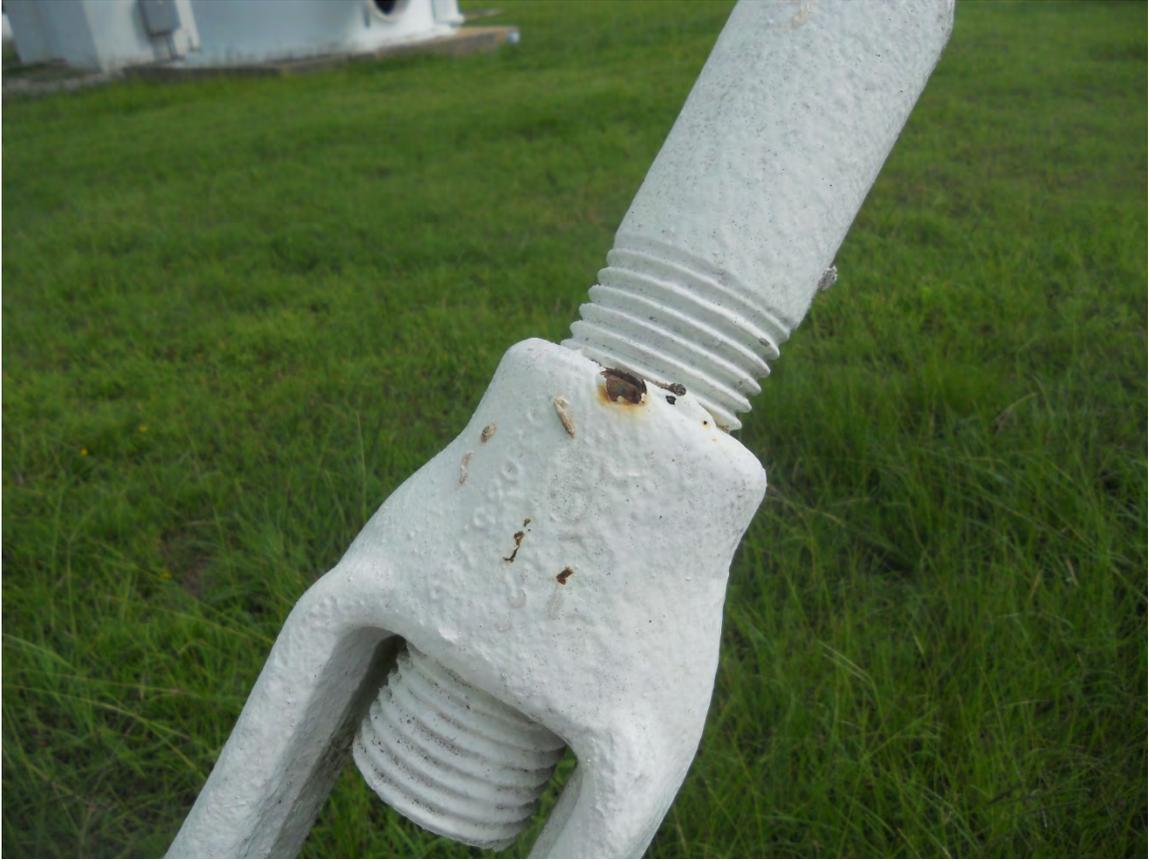
Turnbuckles with rust from damaged coating

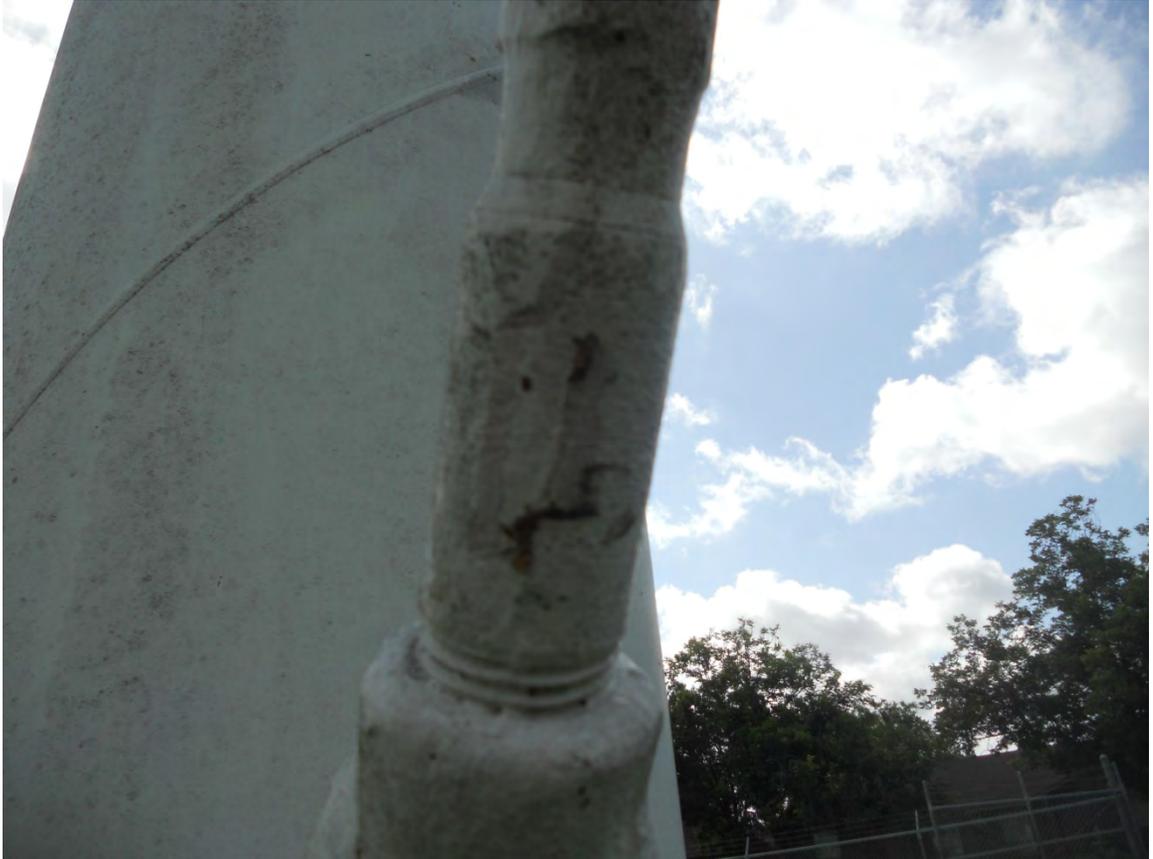
Damaged coating on turnbuckles

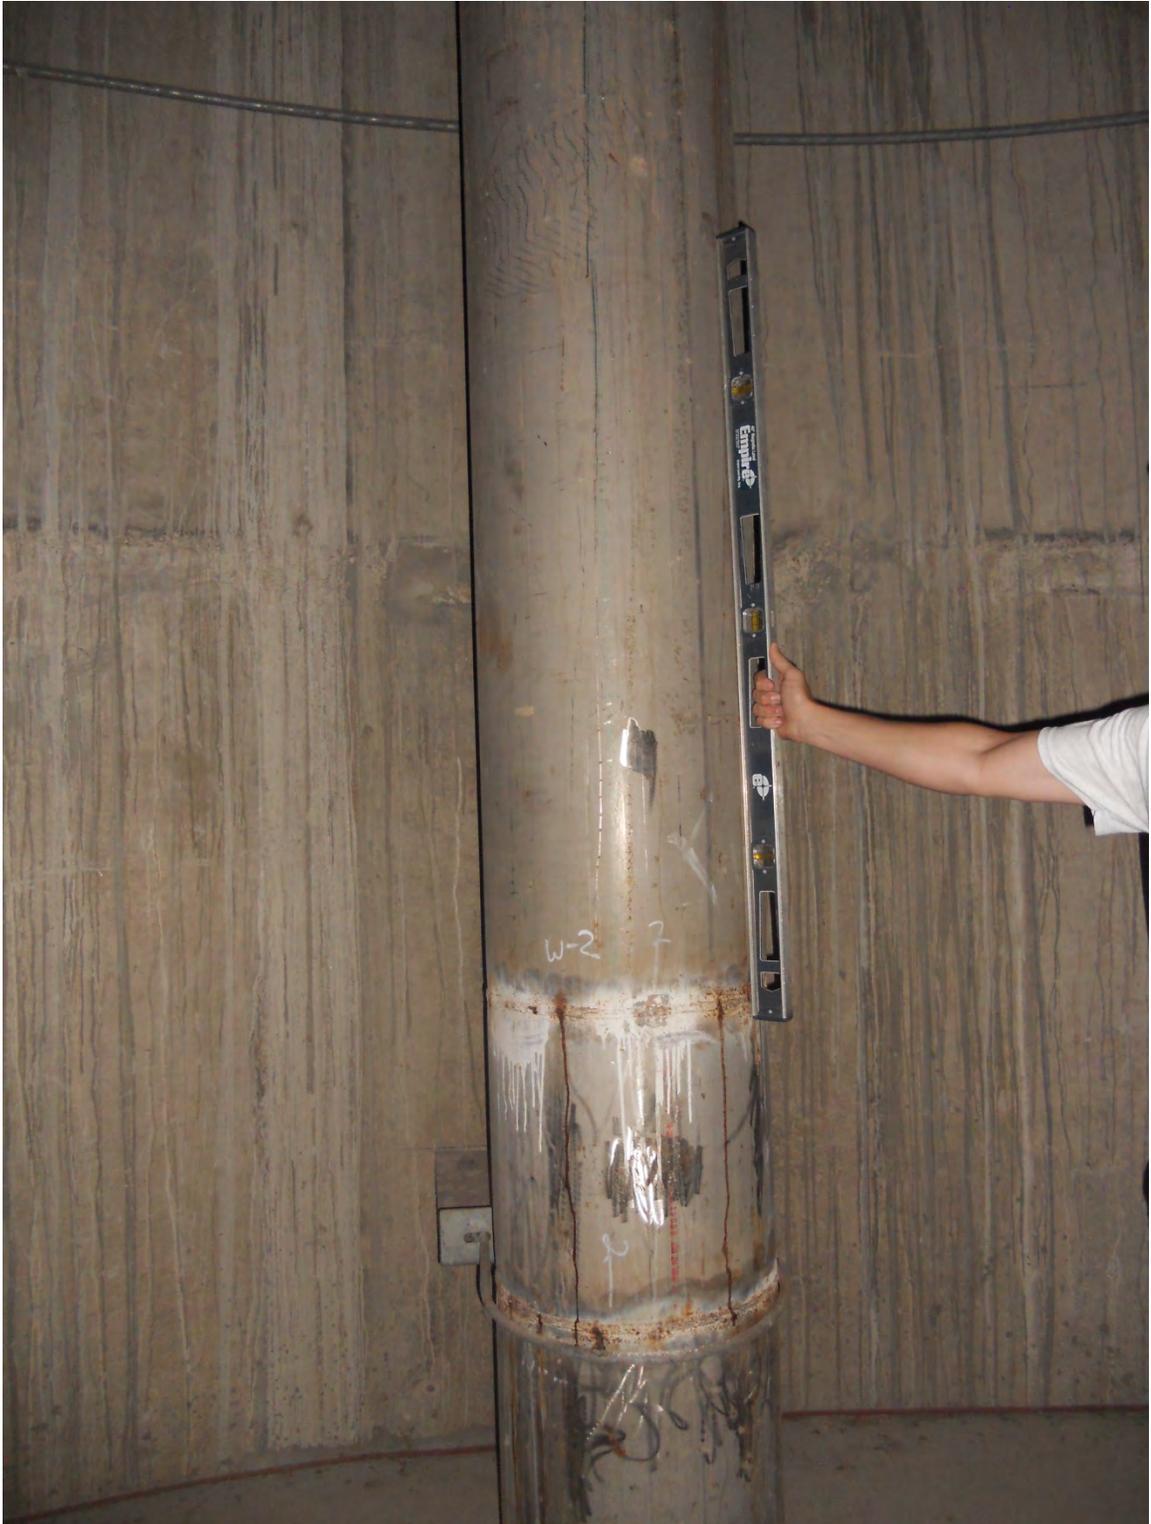
Fill pipe plumb is but weld joints have been repaired several times and currently several pinhole sized leaks are present in joints at second floor

b. The protective coating systems should be replaced in 6 years. Budget \$850,000 to replace the coating systems and fill pipe including engineering fee no later than 2010.
