CONTRACT FOR ENGINEERING SERVICES
Dunham Engineering, INC.

REPORT OF INSPECTION

CITY OF BRYAN

Enclosed please find the reports for the City's steel water tanks. The reports were prepared in accordance with AWWA D101 – Inspection and Repair of Steel Water Tanks. A summary of the results follows:

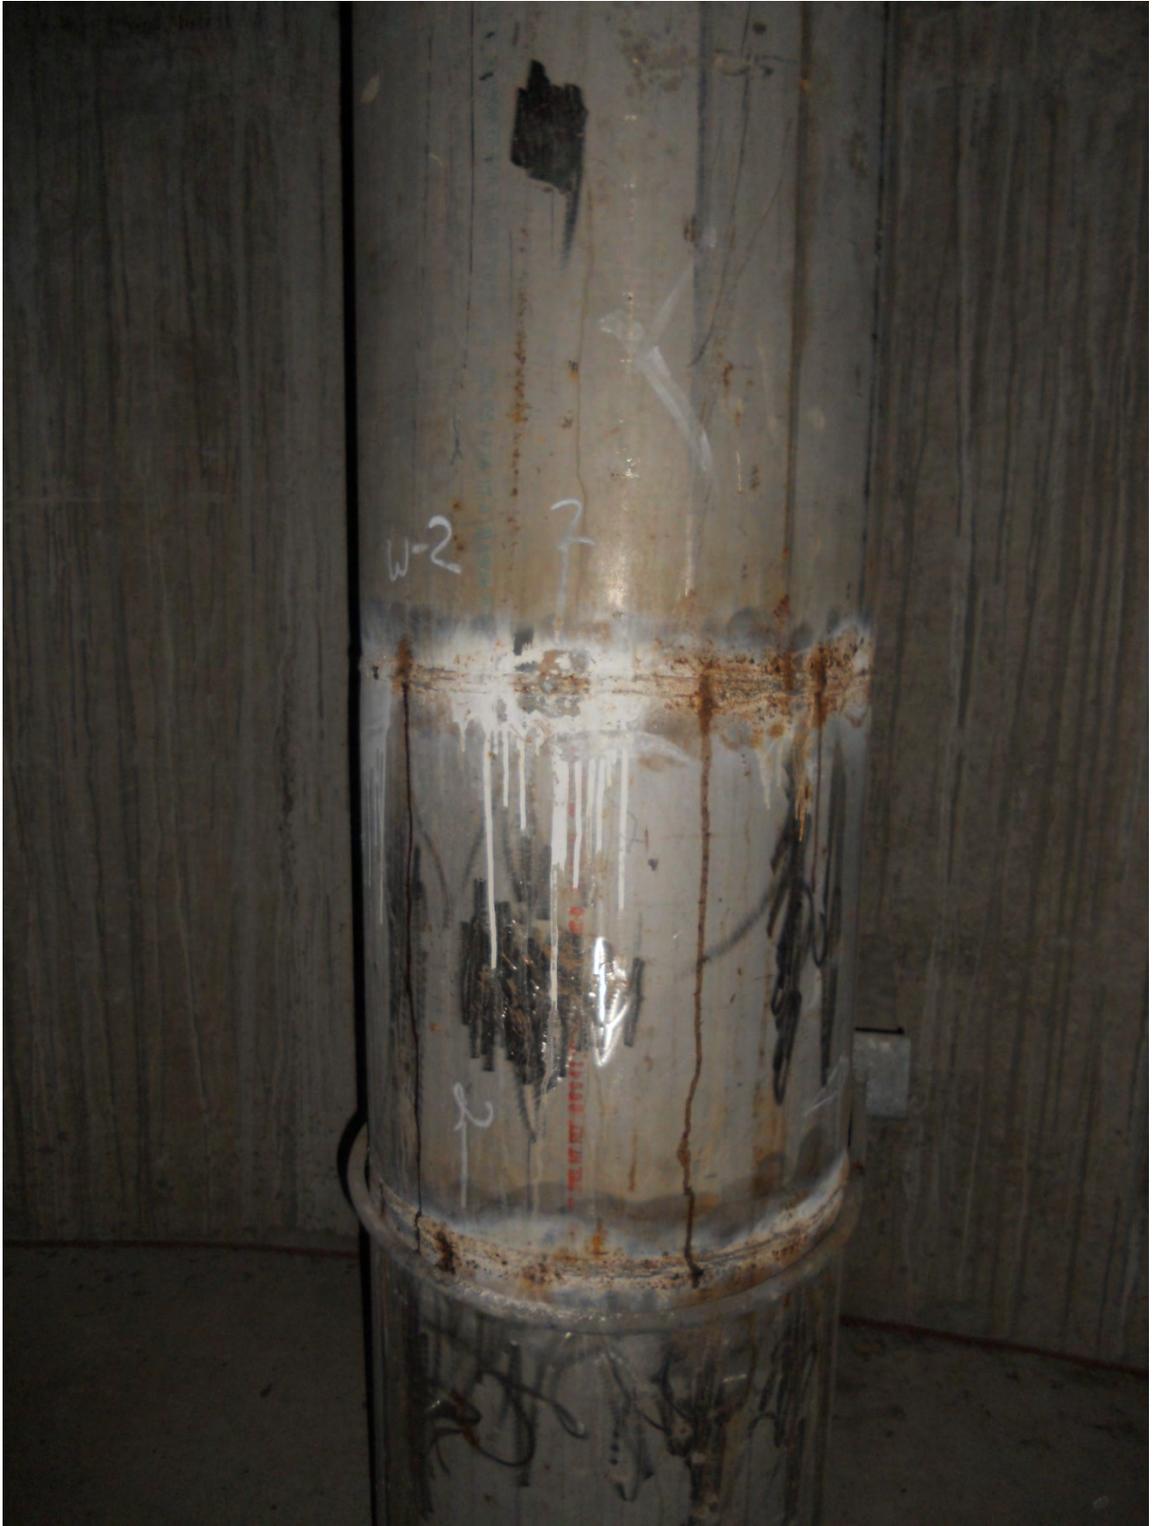
Close-up of leaking welds on fill pipe joints on second floor

b. The protective coating systems should be replaced in 6 years. Budget \$850,000 to replace the coating systems and fill pipe including engineering fee no later than 2010.

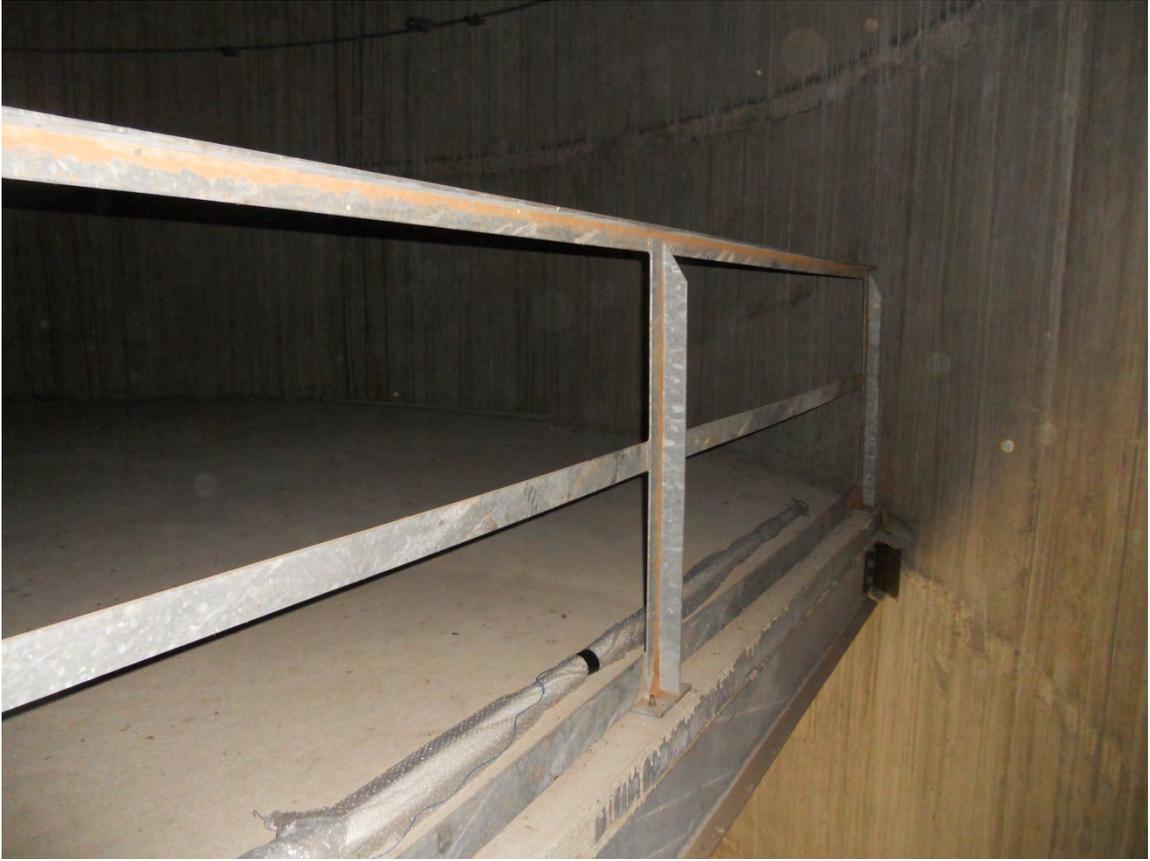
Handrail on second floor protecting circular staircase opening is loose

a. The handrail on the second floor protecting the circular staircase opening is not properly anchored to the concrete floor. The bolts need to be replaced and properly installed now.

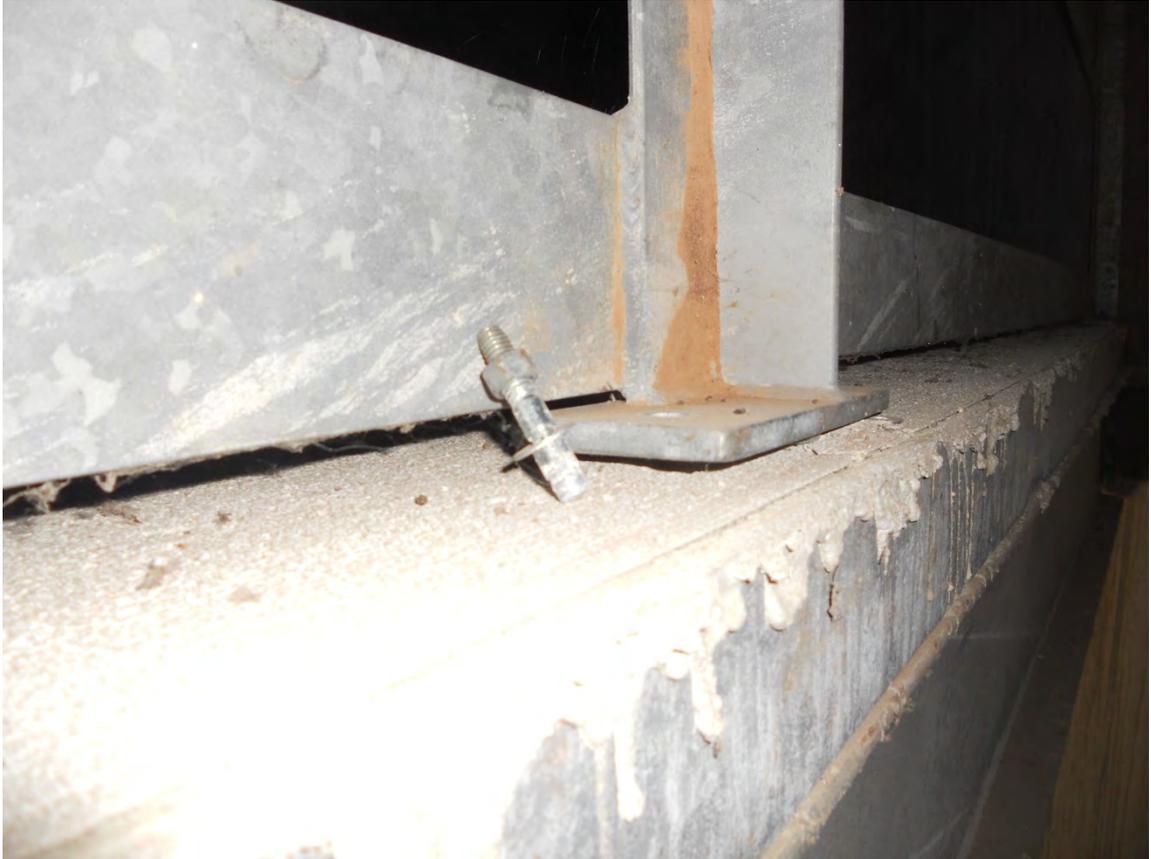
Anchor bolts not embedded in concrete properly

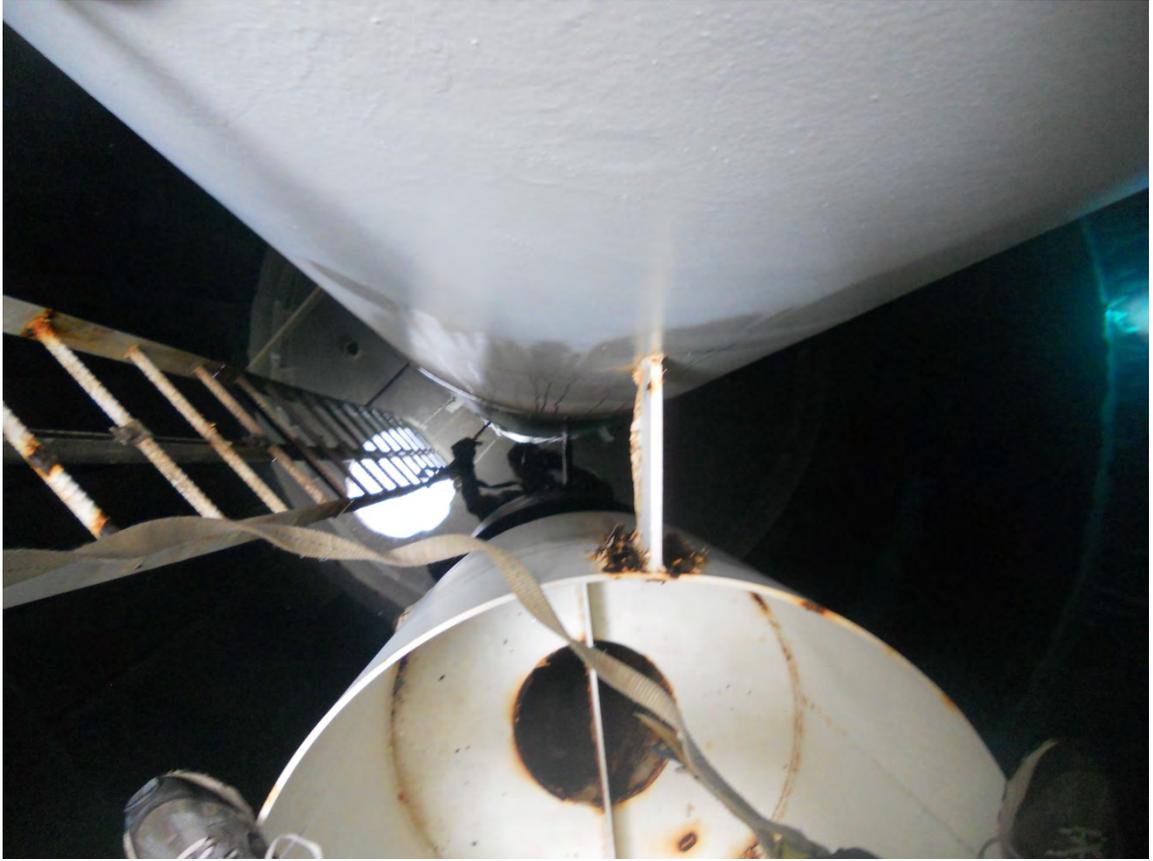
Overflow inlet pipe support rusting
